Environment Monitoring Report

Adani Vizhinjam Port Pvt. Ltd.

Vizhinjam, Kerala

January 2024

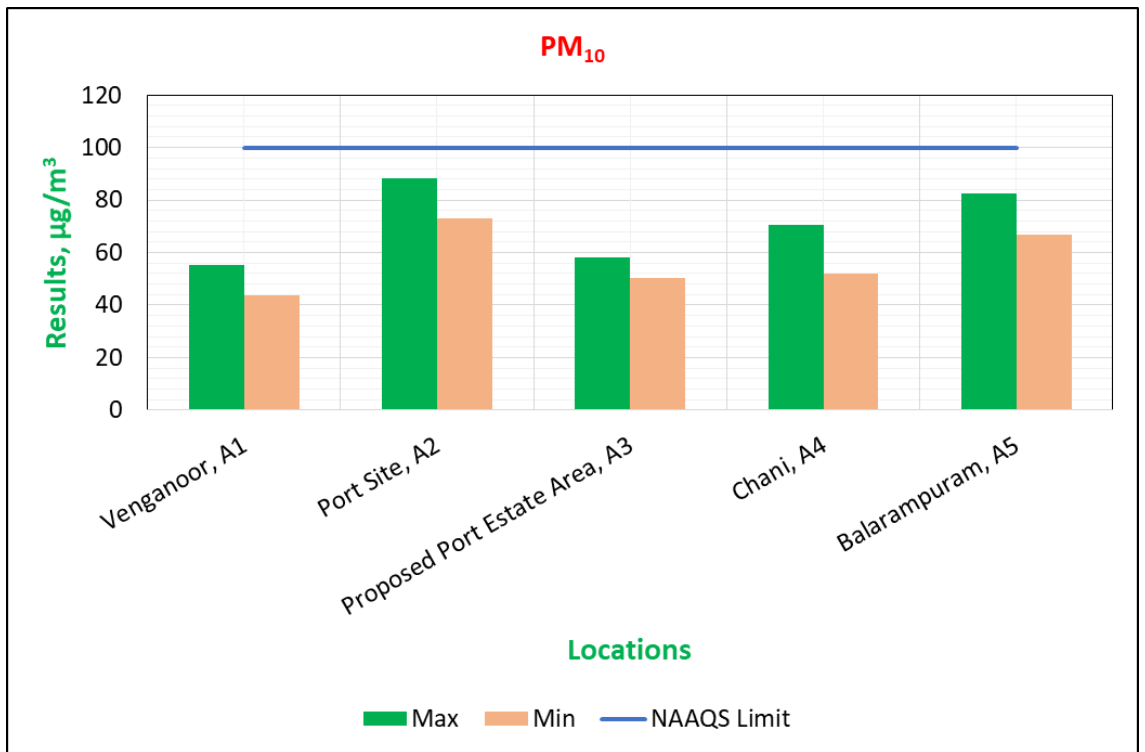
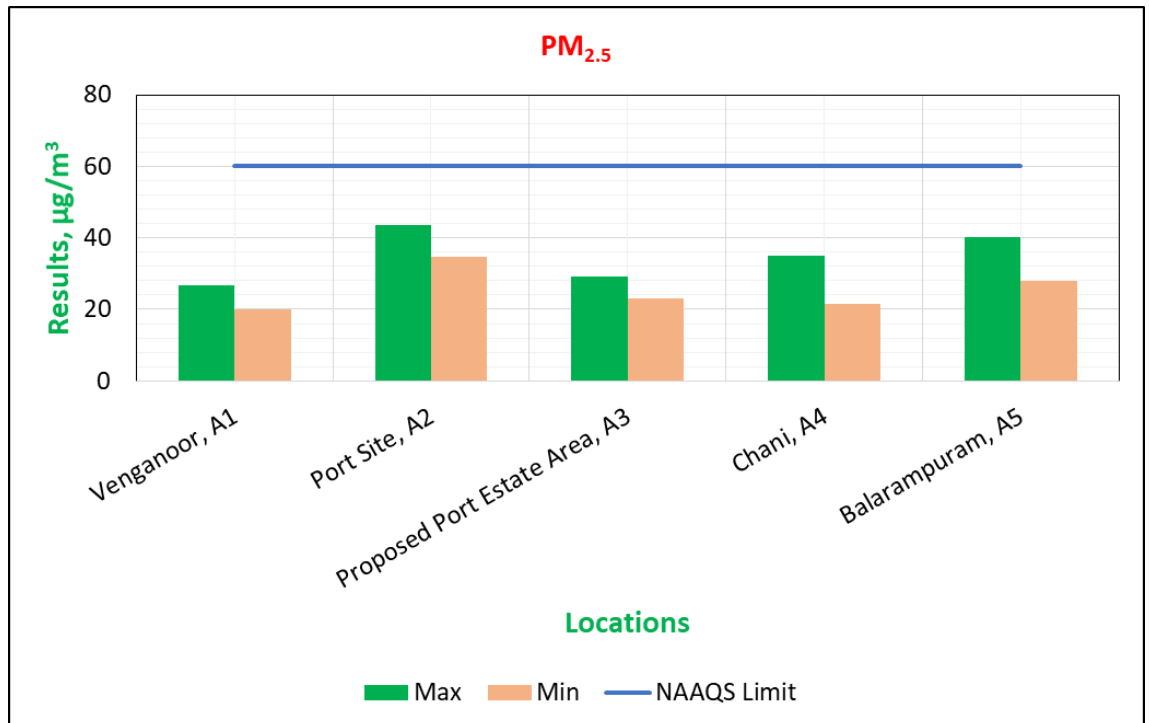
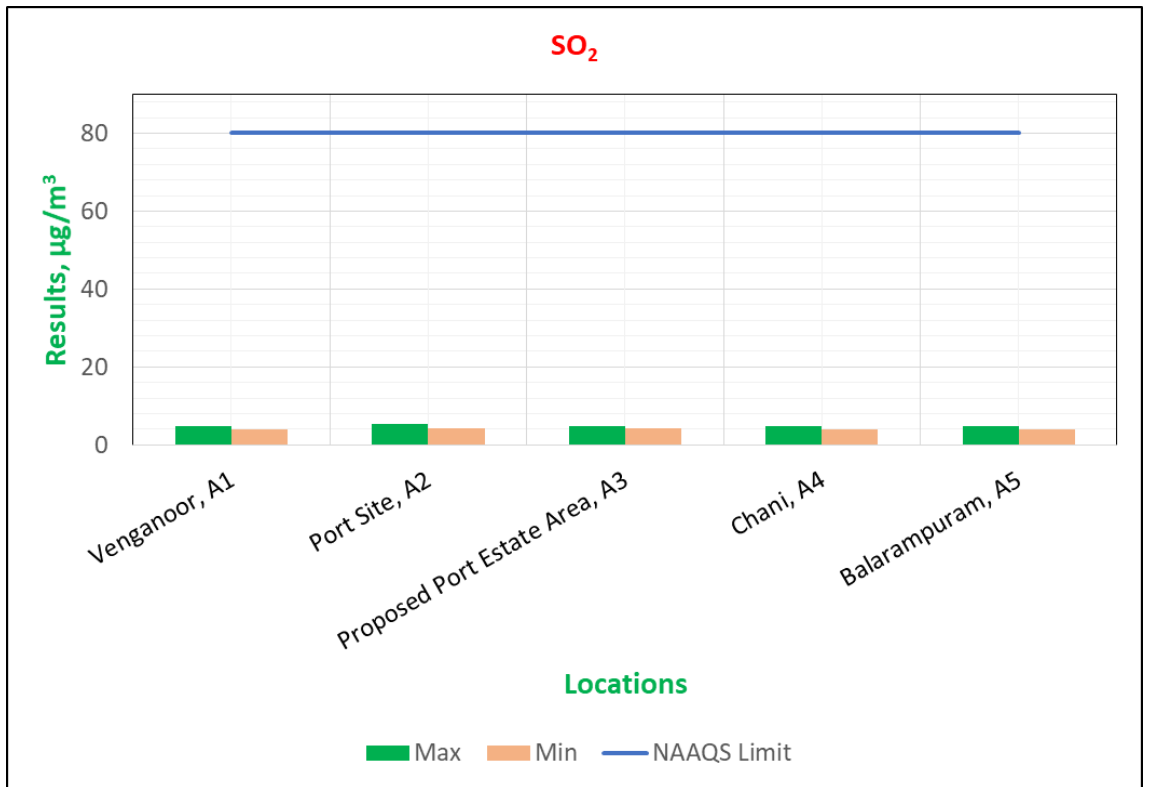
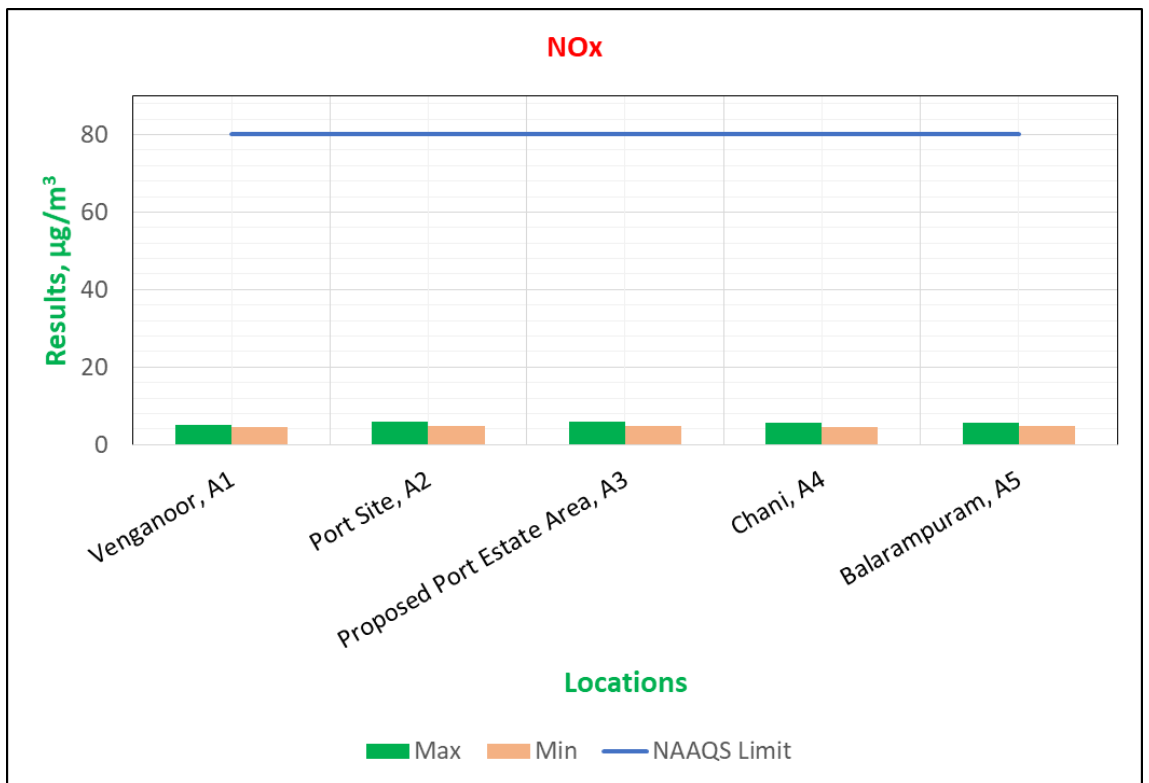
2. Ambient Air Quality

- The ambient air quality monitoring results were observed to be within National Ambient Air Quality Standards (NAAQS), 2009 at all the five locations.
- Noise readings were within limits at all the monitoring locations.
- Marine water and sediment samples results were observed to be comparable with the baseline.
- Ground water samples were collected from 3 locations (open wells). All the parameters at all locations were within the acceptable limits as per IS 10500:2012. The water from these locations is not used for drinking purposes.
- Surface water sample results were observed to be comparable with the baseline.

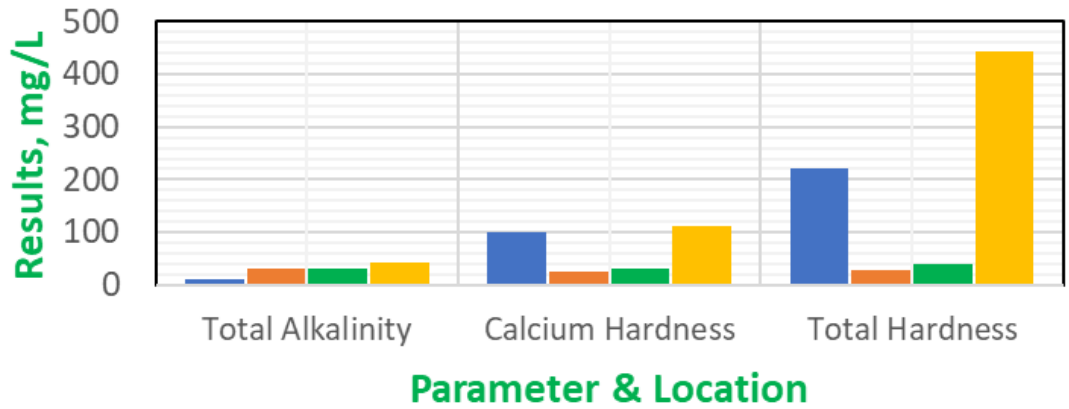
Alkalinity & Hardness

■ Poovar West Canal, S1 ■ Vizhinjam Branch Canal, S2
■ Vellayani Lake, S3 ■ Poovar Estuary, S4
